## SUCTION FITTING INSTALLATION INSTRUCTIONS

## 10-6200 Main Drain Assembly

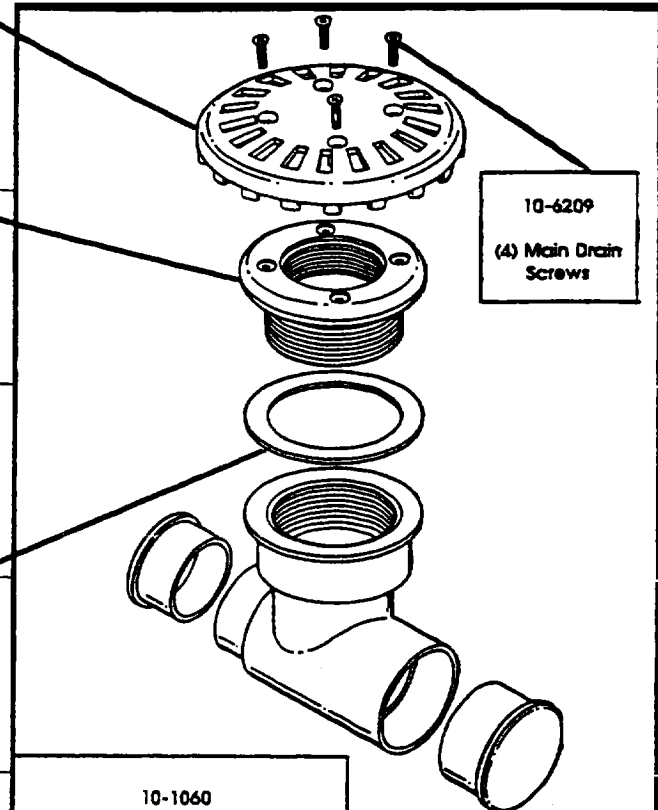
**10-6209**  
**(4) Main Drain Screws**

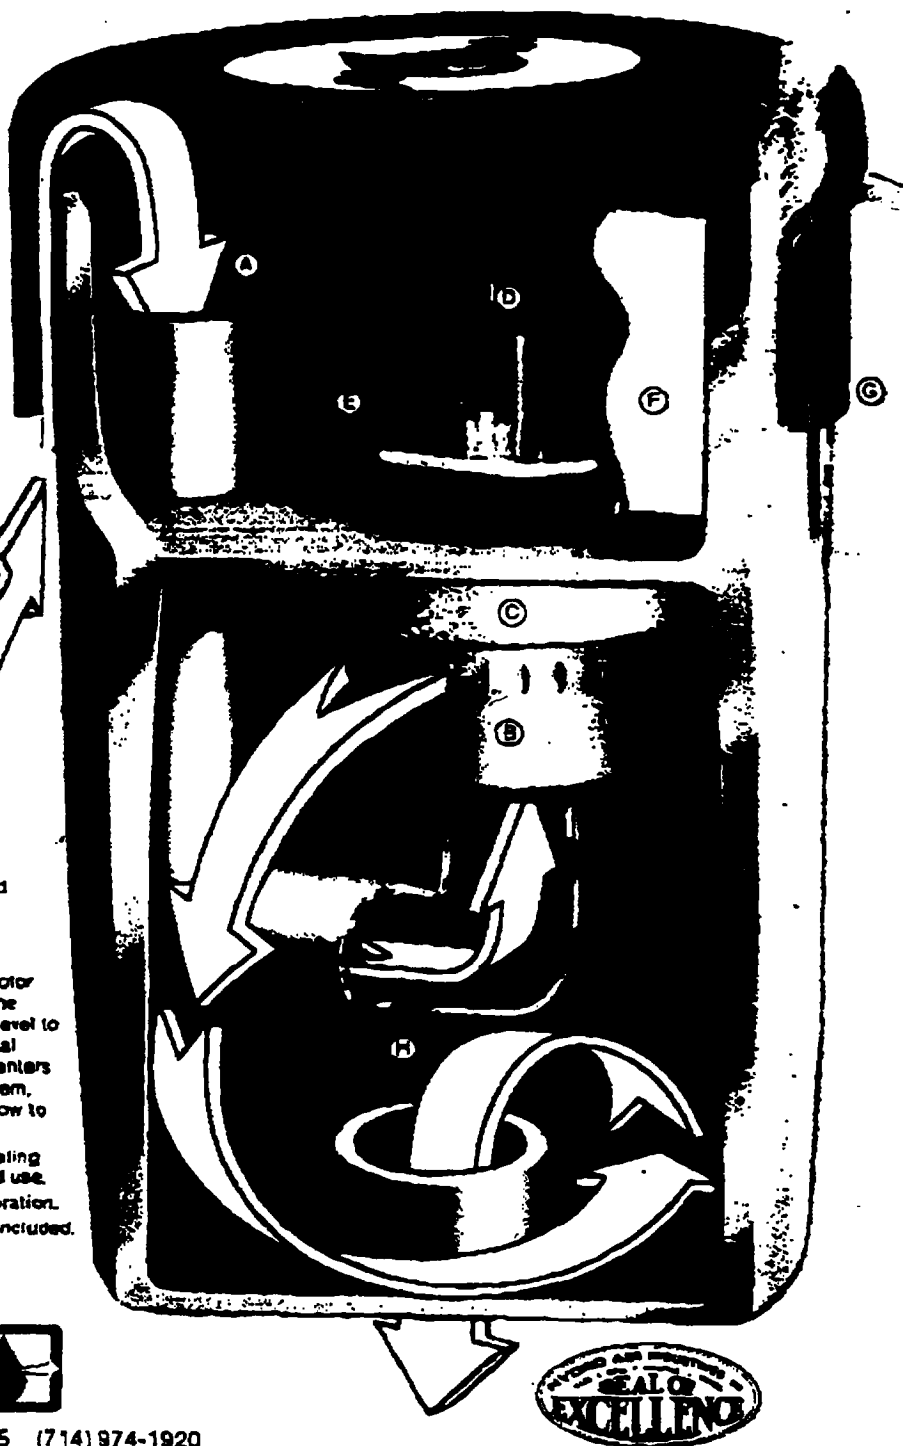
MARIAH AIR PUMP SIZING CHART

- 1) CALCULATIONS ARE FOR A 25' RUN USING 1 1/2" PVC PIPE AND TWO (2) NINETY DEGREE ANGLES. FOR LONGER RUNS, DECREASE QUANTITY BY 10% FOR EACH ADDITIONAL TEN FEET AND 5% FOR EACH ADDITIONAL NINETY DEGREE ANGLE.
- 2) FOR INCREASED ACTION OR IF MORE HOLES THAN LISTED ARE DRILLED, IT MAY BE NECESSARY TO USE TWO AIR PUMPS.
- 3) CALCULATE DEPTH OF WATER TO HIGHEST LEVEL IN SPA.
- 4) IF FEWER HOLES THAN LISTED ARE DRILLED, THE AIR PUMP WILL STILL FUNCTION AS LONG AS A MINIMUM OF 20 3/16" HOLES ARE DRILLED IN THE FLOOR OR SEAT.

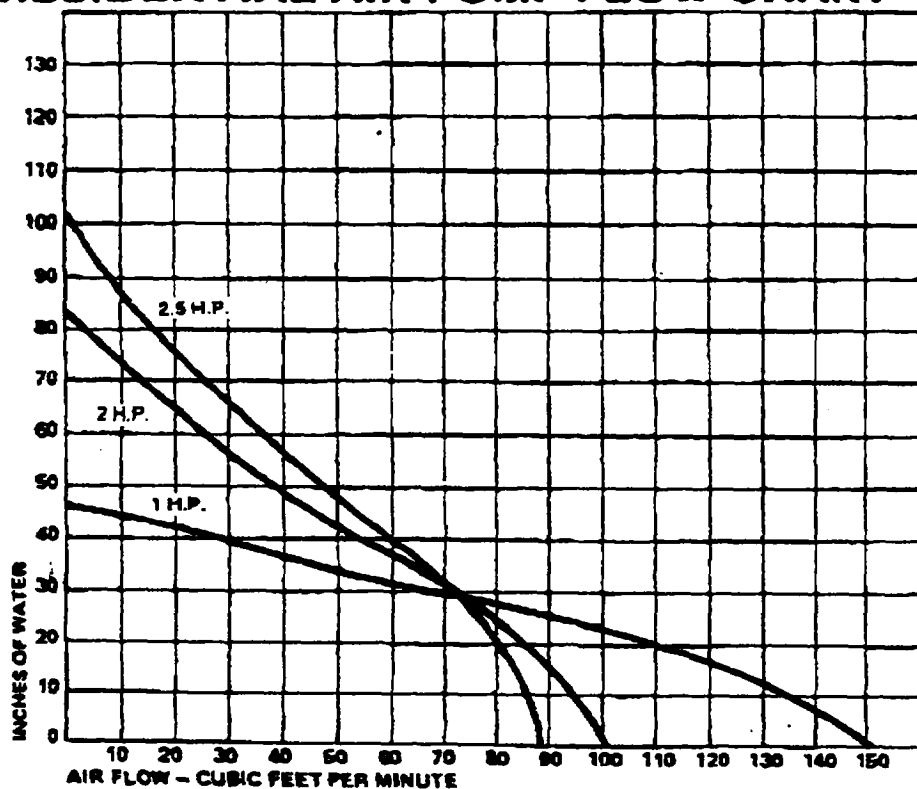
## MARIAH 120/240 VOLT RESIDENTIAL AIR PUMP FLOW CHART

- 1 H.P. —** As an air boost for six (6) jets or for air induction on spas/hot tubs less than 30" deep and 5' x 5' or 25 square feet of surface area.
- 2 H.P. —** As an air boost for six (6) to eight (8) jets or for air induction on spas/hot tubs less than 50" deep and 8' x 8' or 70 square feet of surface area.
- 2.5 H.P. —** As an air boost for eight (8) to ten (10) jets or for air induction on spas/hot tubs less than 60" deep and 10' x 10' or 100 square feet of surface area.

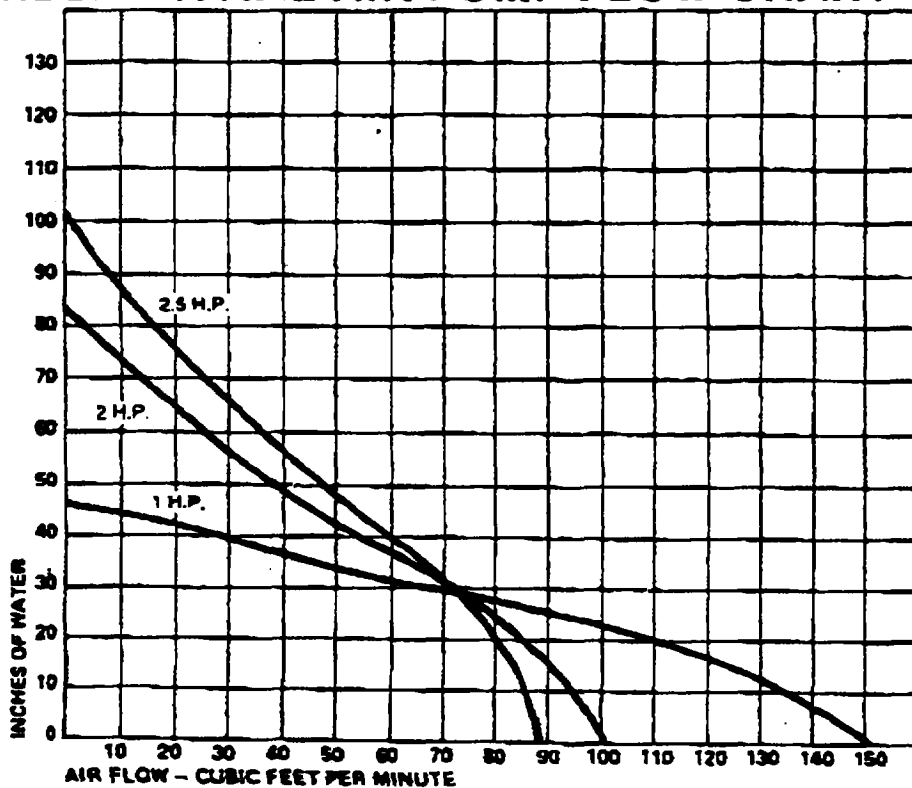
## MARIAH 120/240 VOLT RESIDENTIAL AIR PUMP FLOW CHART

- 1 H.P. — As an air boost for six (6) jets or for air induction on spas/hot tubs less than 30" deep and 5' x 5' or 25 square feet of surface area.
- 2 H.P. — As an air boost for six (6) to eight (8) jets or for air induction on spas/hot tubs less than 50" deep and 8' x 8' or 70 square feet of surface area.
- 2.5 H.P. — As an air boost for eight (8) to ten (10) jets or for air induction on spas/hot tubs less than 80" deep and 10' x 10' or 100 square feet of surface area.

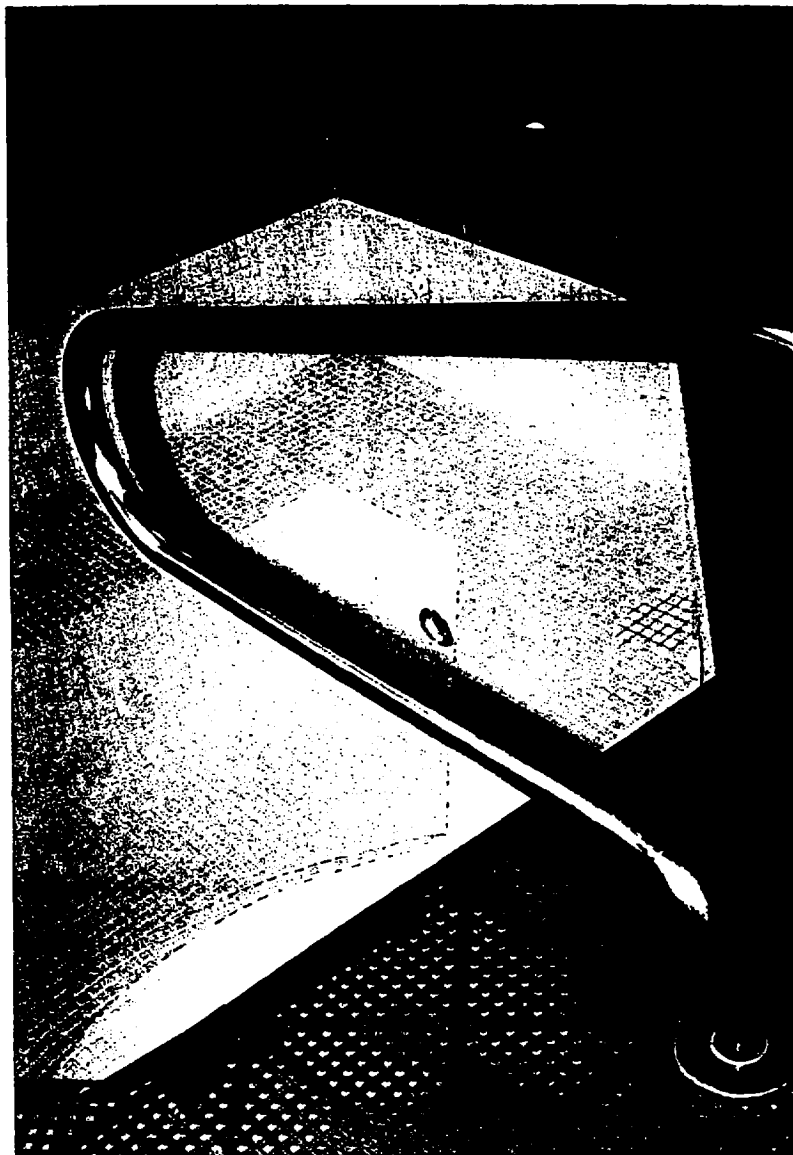
Photo #1: View of hot tub from ground level showing configuration, depth, ledge, drain and hand rail.

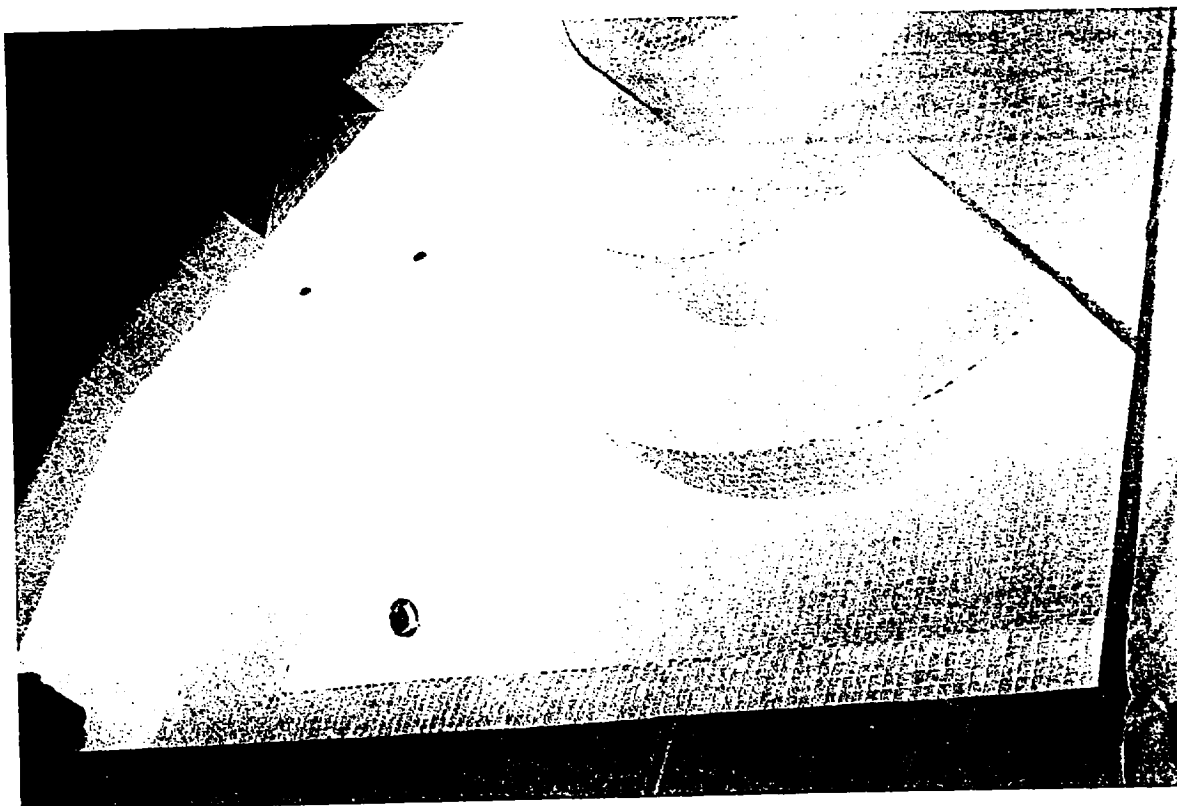
Photo #2: View of hot tub from ground level showing steps and inlets.

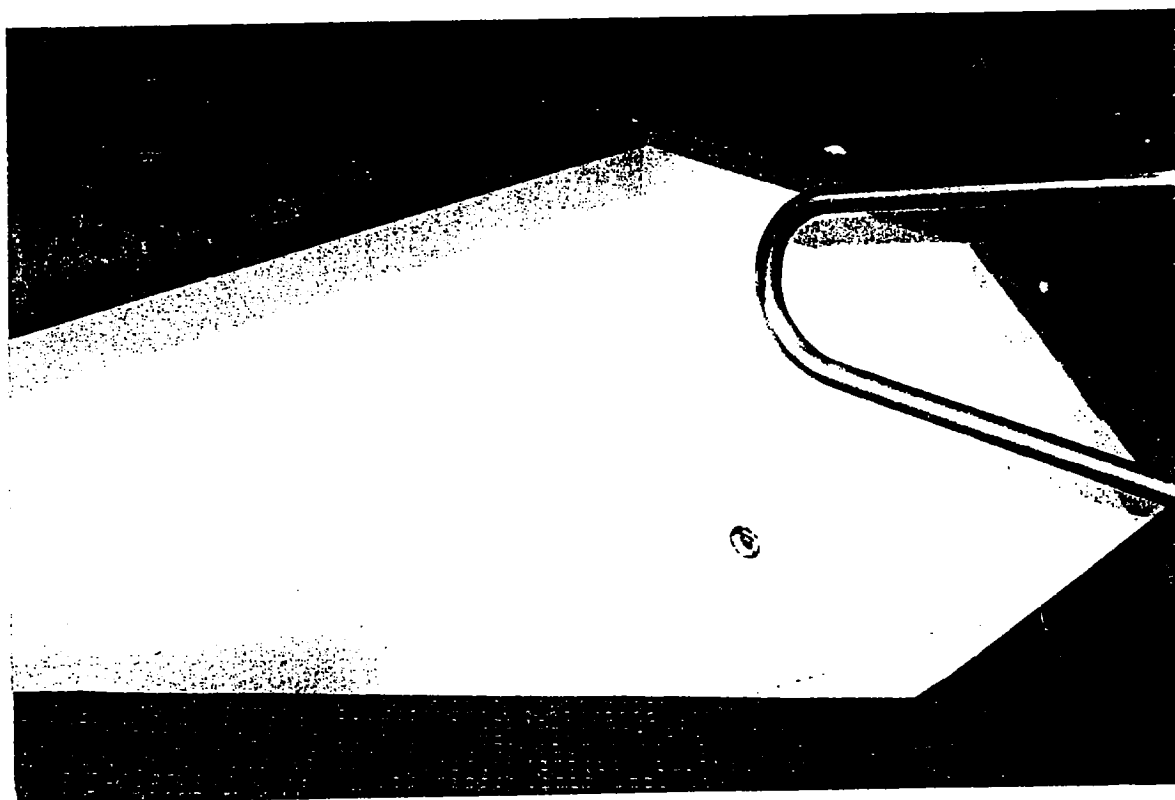
Photo #3: Another view of hot tub.

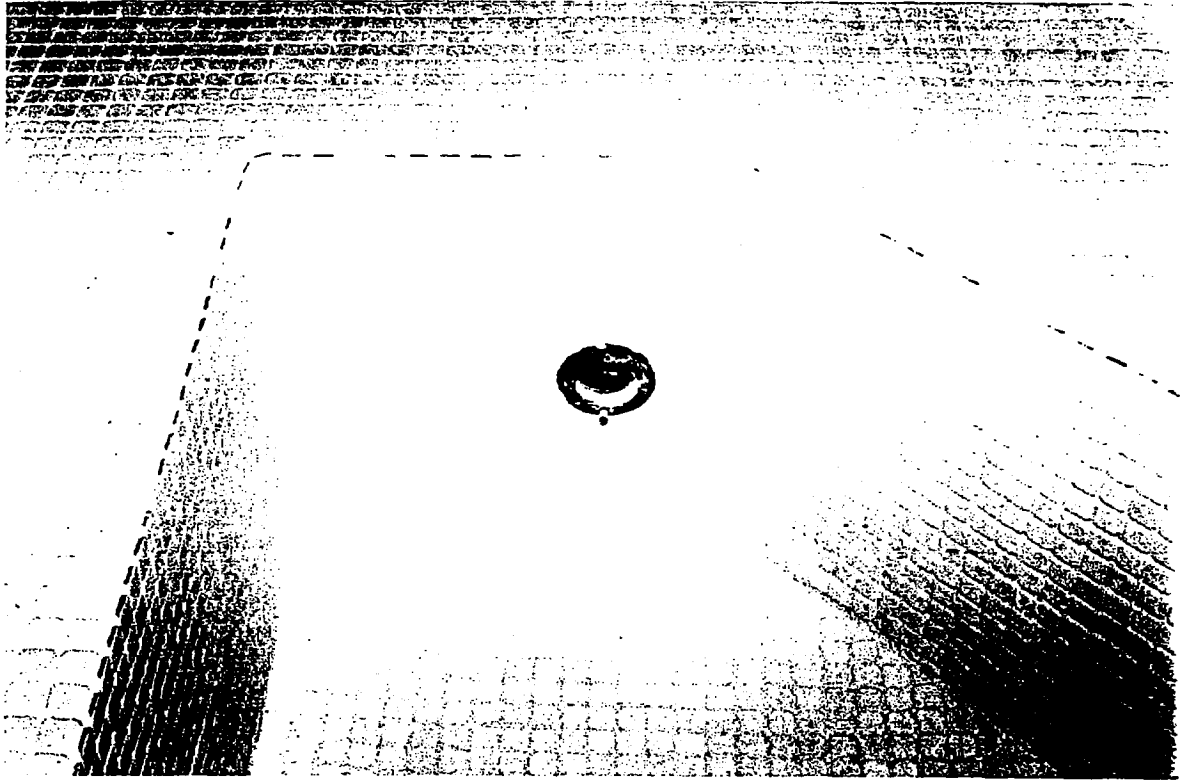
Photo #4: Closer view of floor area, seating ledge and drain.

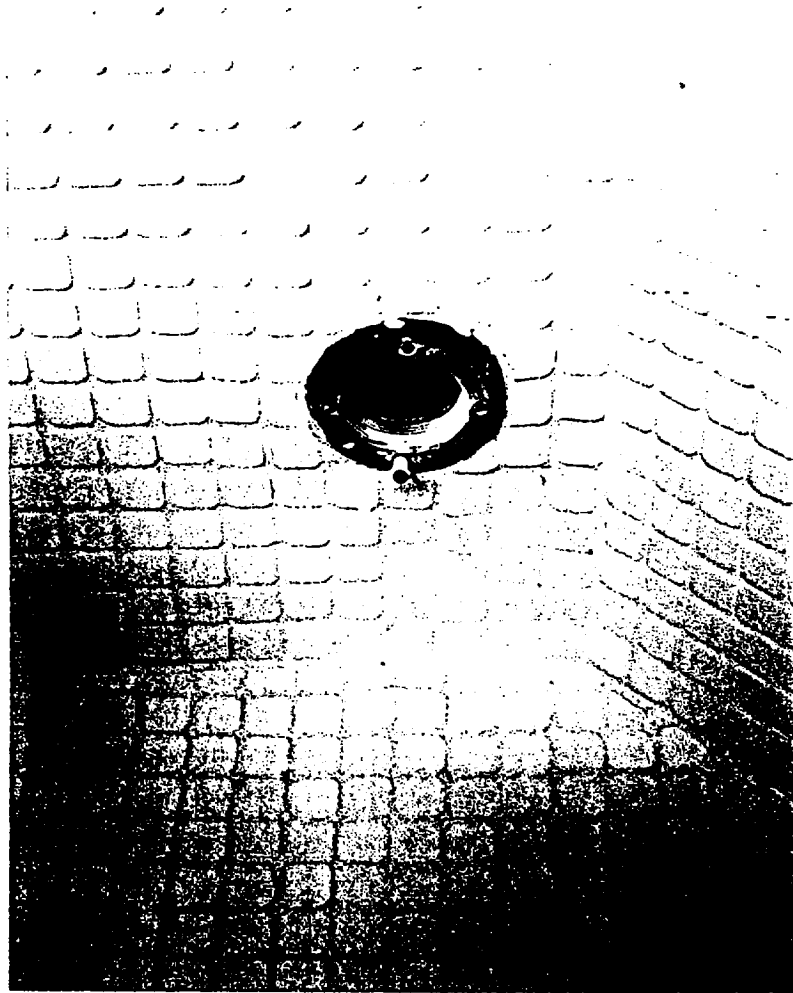
Death appears to be caused from drowning, due to the victim's long hair becoming drawn in to the suction pipe in the hot tub. However there is no sign victim attempted to struggle to get free.

Photo #5: Close up of drain showing remains  
of suction cover.

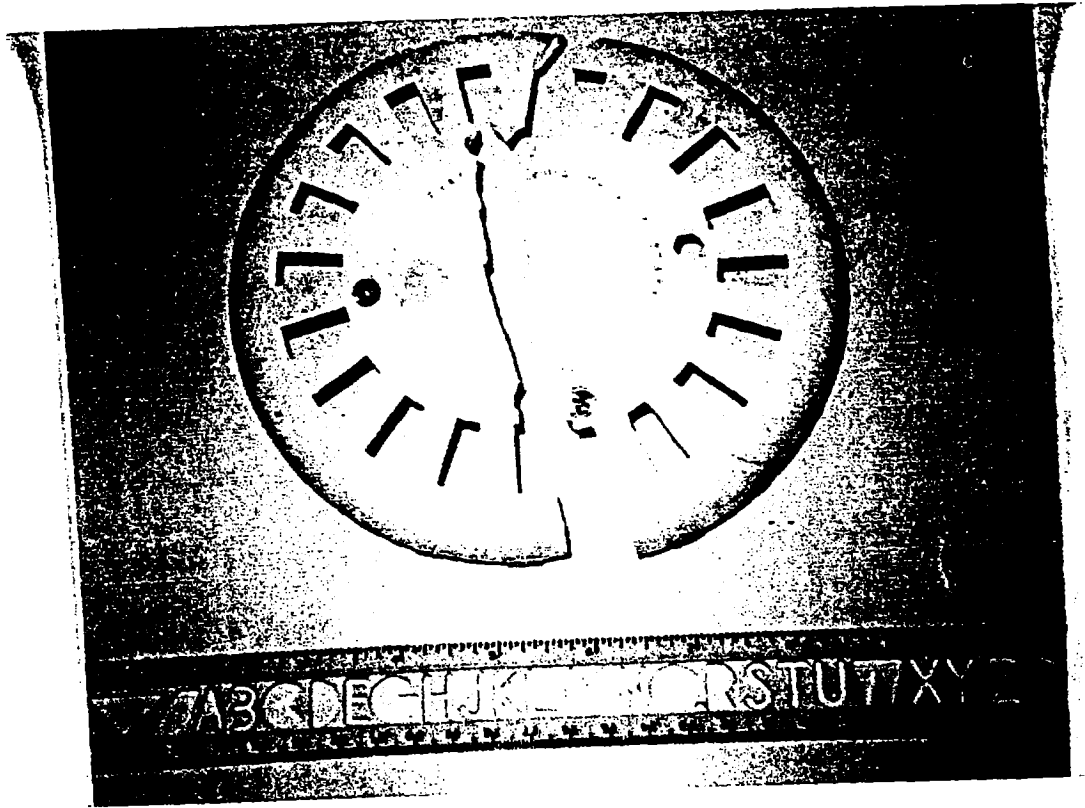
The patient has a luxuriant amount of hair and entangled within this hair is a plastic object. When removed, this is seen to be circular in shape, broken into two parts and measures approximately 14.5 cm in diameter. This object has numerous holes and is consistent with a drain guard.

Photo #6: Close up of suction cover.
